Record Keeping and Archiving of Materials' Sample for Sustainable Floor Tiles Maintenance

The Faculty of Built Environment of the Universiti Teknologi Malaysia as shown in figure 1 is located at the middle of the university's campus and it's popularly referred to as the centre point. The Faculty has four departments which are Architecture, Quantity Surveying, Landscape Architecture and Urban and Regional Planning with 455 postgraduate students and 891 undergraduate students. The population of academic staff is 100 while 47 others are supporting staff. These are constant users of the building apart from several others that use the corridors as passage way. The Universiti Teknologi Malaysia is located in Skudai near Johor Bahru the capital of Johor State of Malaysia. It is the South most state in Peninsular Malaysia. It shares boundaries with Singapore, Indonesia and the South China Sea. It lies between latitude $1^{\circ}21'$ and $2^{\circ}35'$ of the equator. The average rainfall is 1778mm with 82-86% humidity.

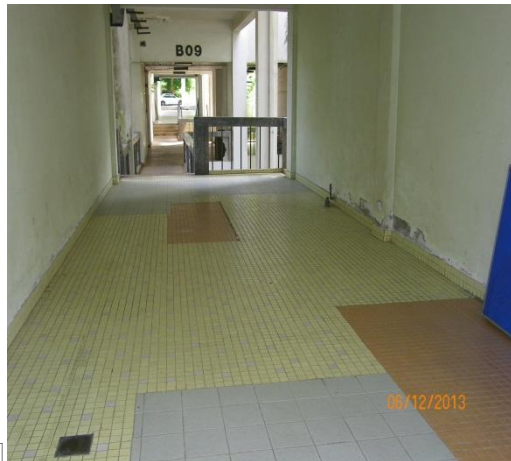
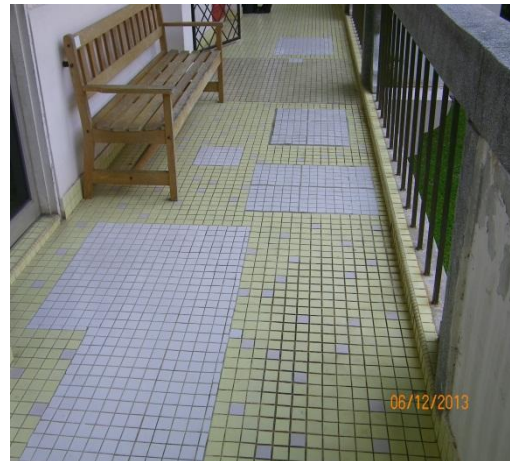
The patches of different colours and sizes of tiles used as replacement for faulty ones during maintenance works as shown in figure 2a and b, figure3a and figure4a and b exemplify the outcome of lack of records and archived samples that can be used to order for exact product for replacement on maintenance due date. It shows the disadvantages of not using the same type of tiles. From these figures that show the current situation in all the blocks of the Faculty and the School in general, it is obvious that the tilling no longer complies with any pattern or rhythm and consequently constitutes an ugly sight. The aesthetics have been compromised. Silvestre and de Brito (2011) identified this as aesthetic anomalies in the works of Goldberg (1998) even though it may not affect some other functions that the tiles are meant to perform such as protecting the floor structure against environmental aggression as stated by Zhao and Zhang (1997)

Figure 2a and b: Different patches, sizes and colours in balconies and passages

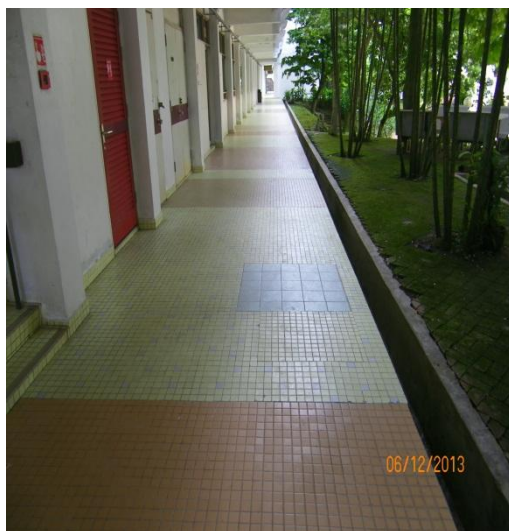
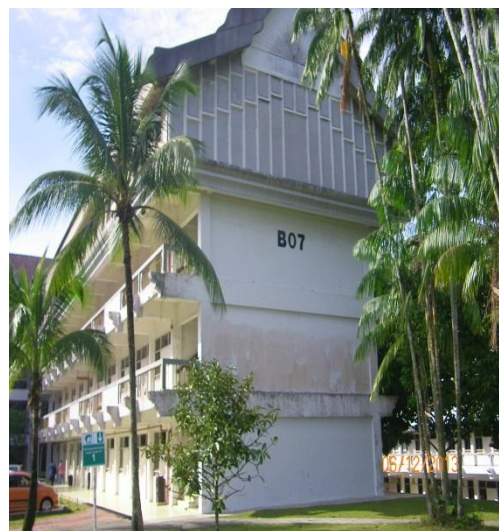
Figure 3a and b: Different patches and colour along a single corridor and a typical block

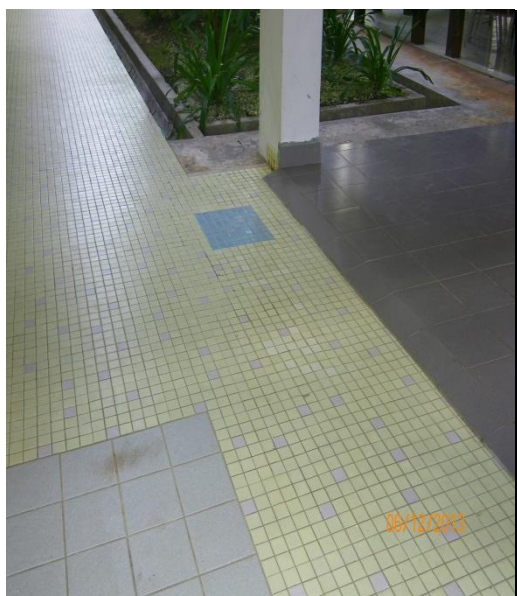
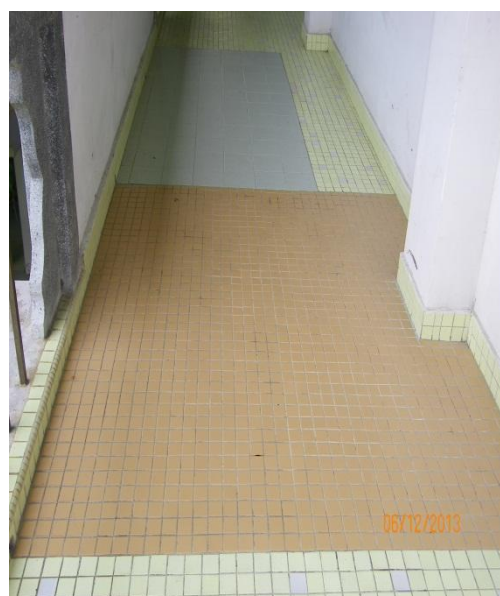
Figure 4a and b: No pattern or rhythm
